**Region 9 Enforcement Division
75 Hawthorne Street
San Francisco, CA 94105**

Inspection Date(s):	9/28/2015		
Time:	Entry: 1:20 pm	Exit: 3:20pm	
Media:	Water		
Regulatory Program(s)	Clean Water Act NPDES /CAFO Dairy		
Company Name:	El Dorado Dairy		
Facility or Site Name:			
Facility/Site Physical Location:	13566 Bon View Ave , Ontario, CA 91762		
Geographic Coordinates:			
Mailing address:	PO Box 1590, Chino, CA, 91708-1590		
Facility/Site Contact:	Ed Haringa	Title: Operator	
	Phone: [REDACTED]	Email:	
Facility/Site Identifier:	NPDES CAG018001 / Order R8-2013-0001, General waste discharge requirements for CAFOs (dairies and related facilities)		
NAICS:	112120 Dairy Cattle and Milk Production		
SIC:	0241 Dairy Farms		
Facility/Site Personnel Participating in Inspection:			
Name	Affiliation	Title	Email
Ed Haringa		Operator	
EPA Inspector(s):			
John Tinger	EPA	Engineer	Tinger.John@EPA.gov
Federal/State/Tribal/Local Representatives:			
Edward Kashak	WRCB-R8	Engineering Geologist	ekashak@waterboards.ca.gov

SECTION I – INTRODUCTION

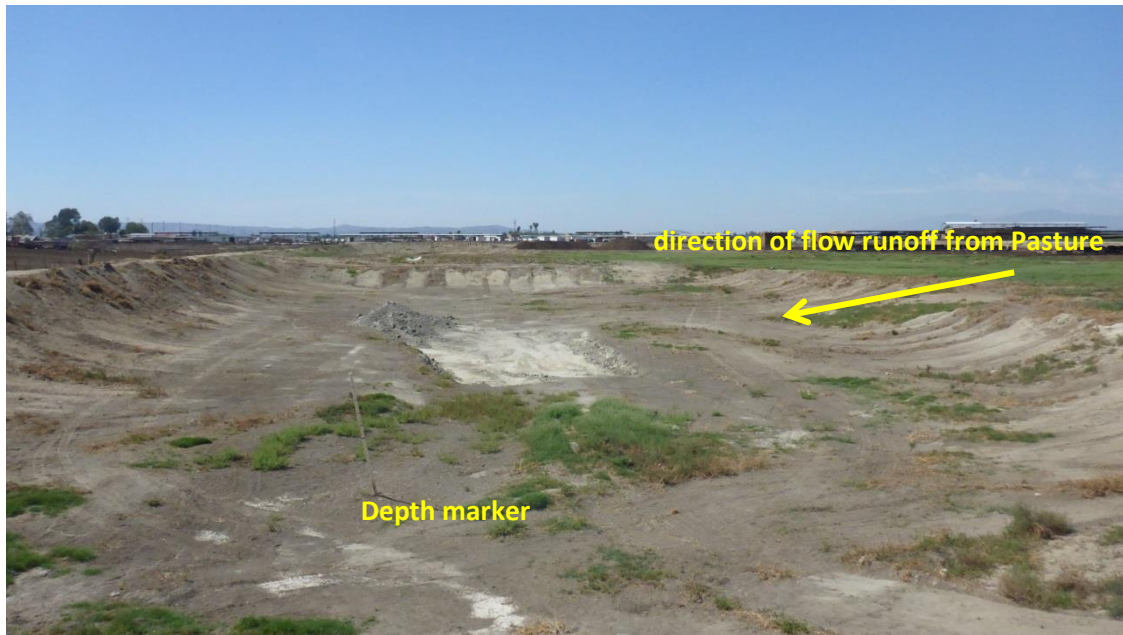
- The pond marker in the southeast pond was askew and should be stabilized; the operator stated cows like to rub against it.

Photo 1: Southeast corner of facility. Southeast Pond and pasture areas. View looking west.

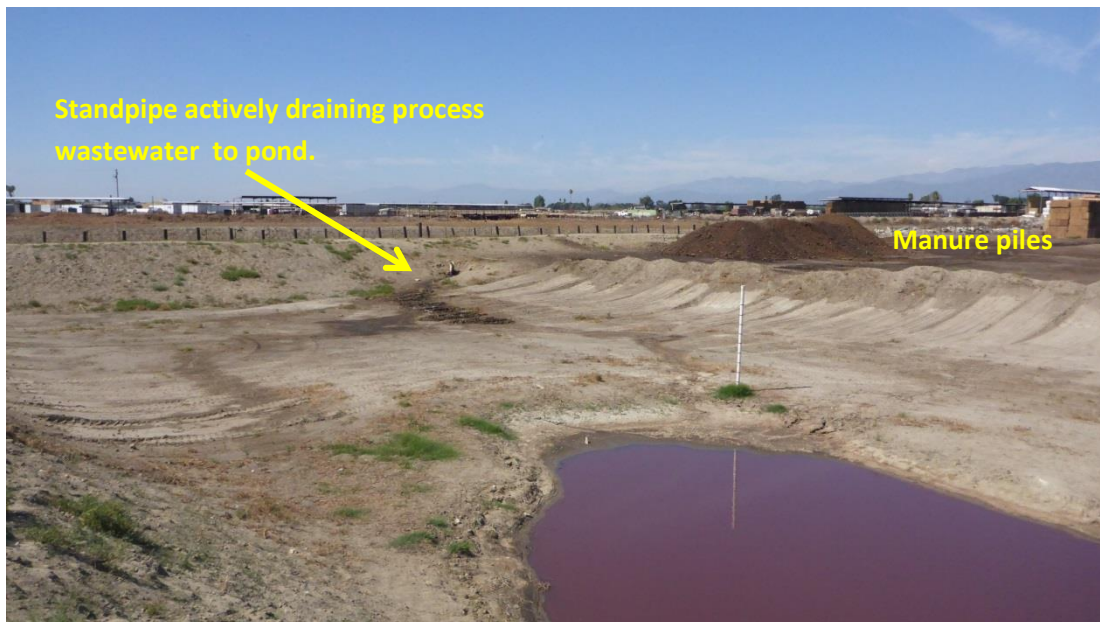
The drain is piped to a standpipe discharging to the southwest pond (see photo 2).

At the time of the inspection, the southwest pond held several feet of wastewater. (photo 2) The operator noted the water remained from the rains in July. The operator stated most wastewater is either evaporated or pumped to pasture with little infiltration. The ponds are not maintained to encourage infiltration. At the time of the inspection, wastewater was actively draining to the standpipe in the southwest pond. The water originated from misting at the western edge of the corrals. Standing water was observed at the western edge of the corrals due to misting.

Photo 2: Southwest corner of facility.

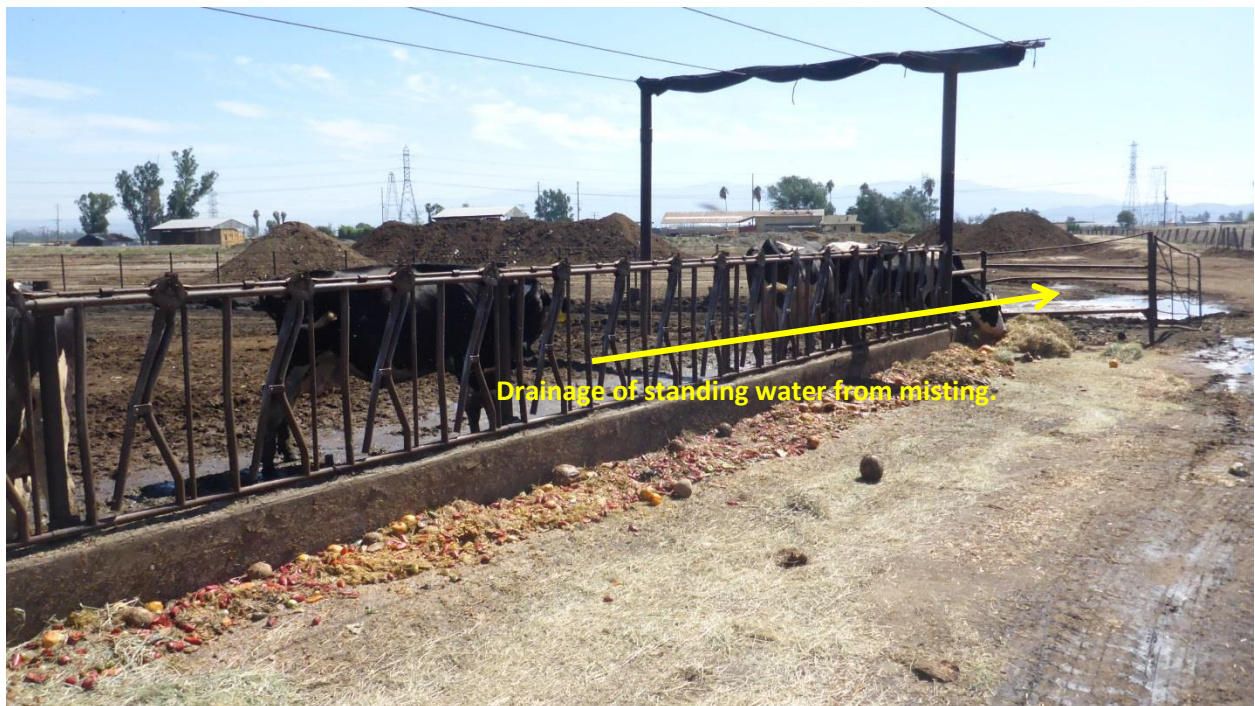
Photo 4: Western edge of corrals. Misting water draining to SE pond.

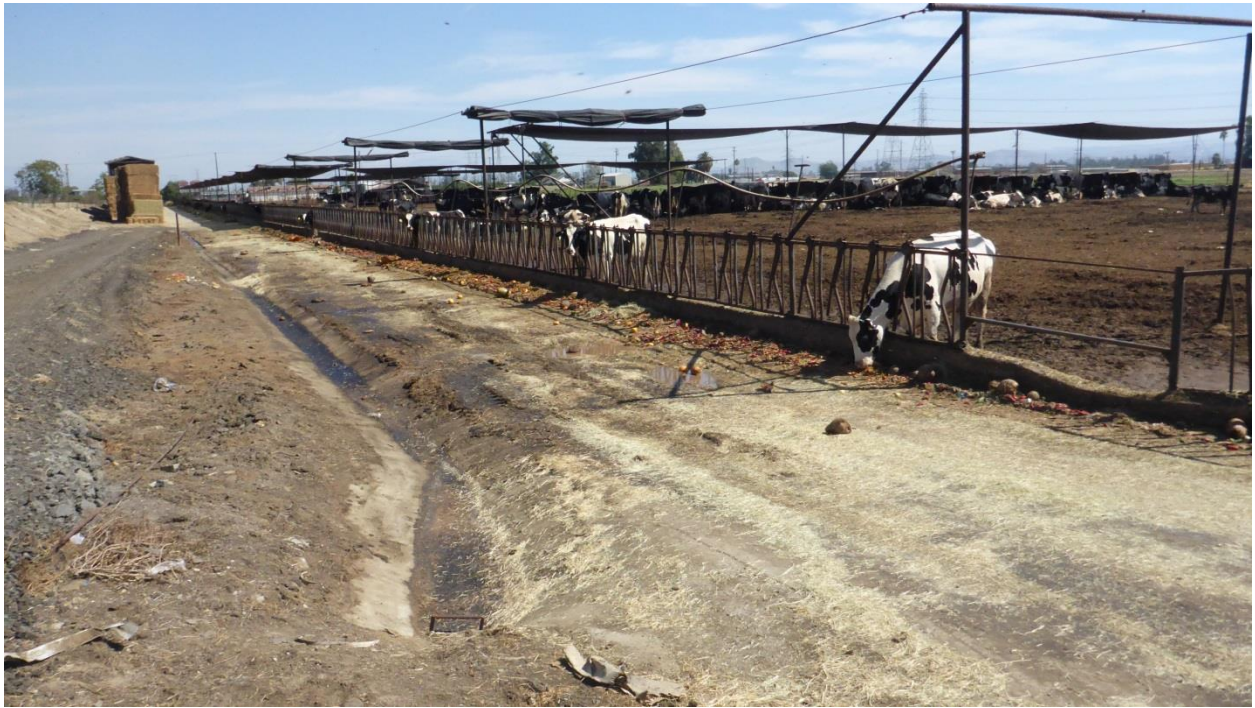
Photo 5: Drainage along northern boundary.

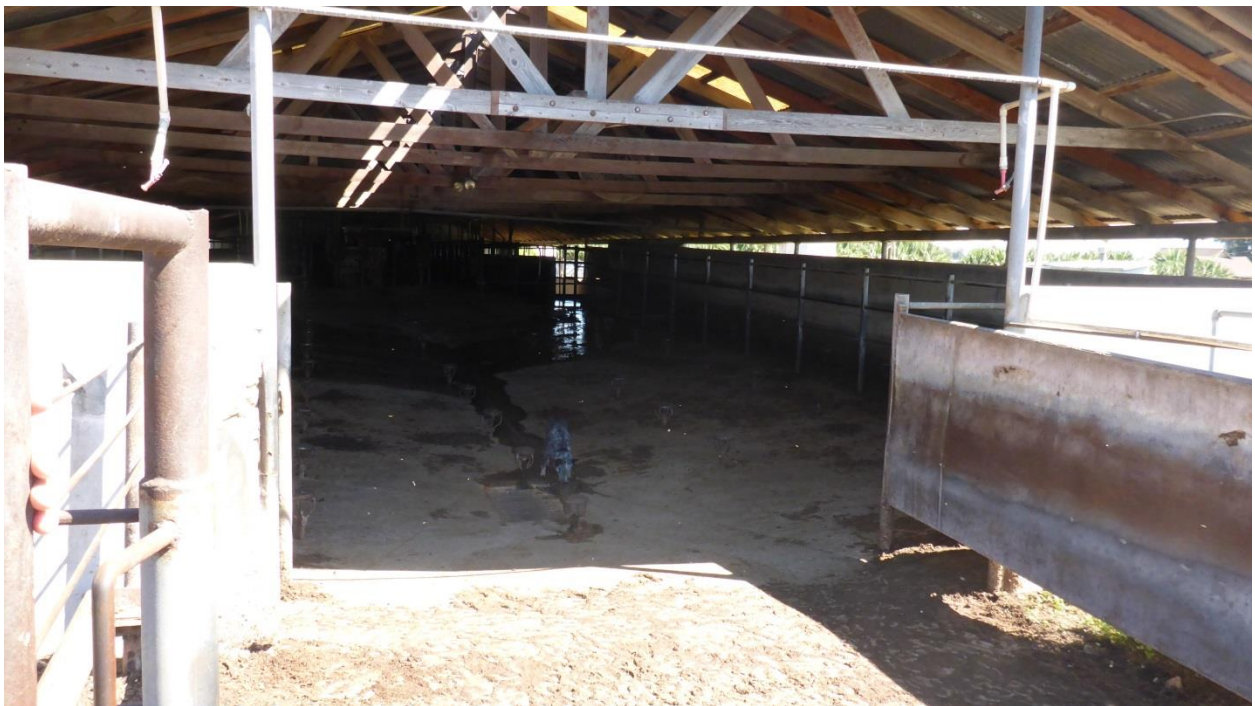
Process water from the milk barn drains to a pipe which is directed to pasture areas in the center of the dairy (photo 6). There are several check valves in the pasture areas where the operator directs wastewater to different areas of the pasture. Pasture is planted with ryegrass. Stormwater that overflows the pasture areas, along with stormwater from the corrals, sheet flows directly into the southeast pond (photo 1). At the time of the inspection, the southeast pond was dry. At the time of the inspection, a section of the southeast pond had been scraped below grade. The operator explained this was to facilitate a ponding area to collect pond water so that it could be pumped back to the pasture areas for irrigation.

Photo 6: Washwater from empty milk barn area going to drain. Drain is directed to pasture area.
